General Summary

Complete Home Inspection Services, LLC

Address
123 Main St
Tampa FL 33607

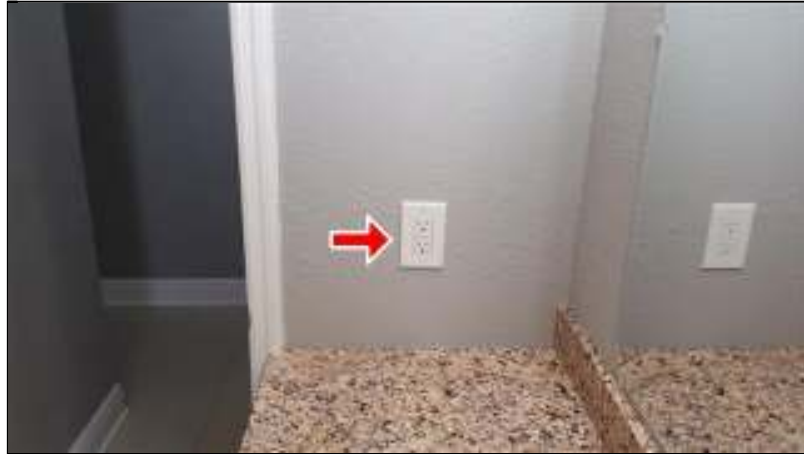
2.5 Item 1(Picture)

One GFCI (Ground Fault Circuit Interrupter) outlet at the Hall Bath wont "trip" when tested. Electrical issues are considered a hazard until repaired. A qualified licensed electrical contractor should perform repairs that involve wiring.

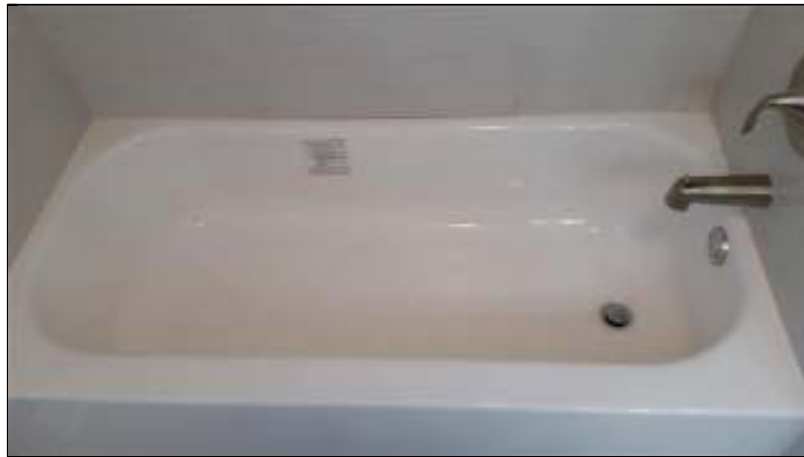
3.1 Item 1(Picture)

The tub drain drains slowly under the hall bath. A cause of a slow drain can range from a simple cleaning at stop valve or at the trap under sink. Sometimes the drain can be partially clogged down line. I am unable to determine the cause of the slow drain. A licensed plumber should troubleshoot further to determine cause or remedy.

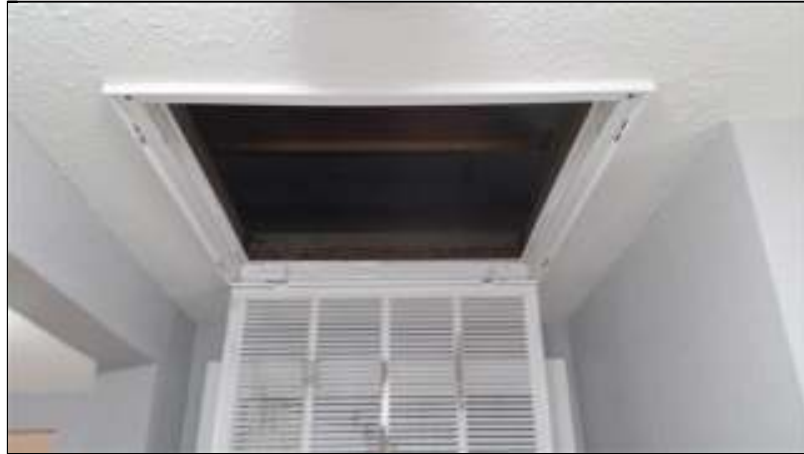
4.1 Item 2(Picture) thick dust in duct

(1) The air condition ductwork requires cleaning. This normal maintenance. I recommend an evaluation by a licensed air condition contractor.

4.1 Item 1(Picture) return

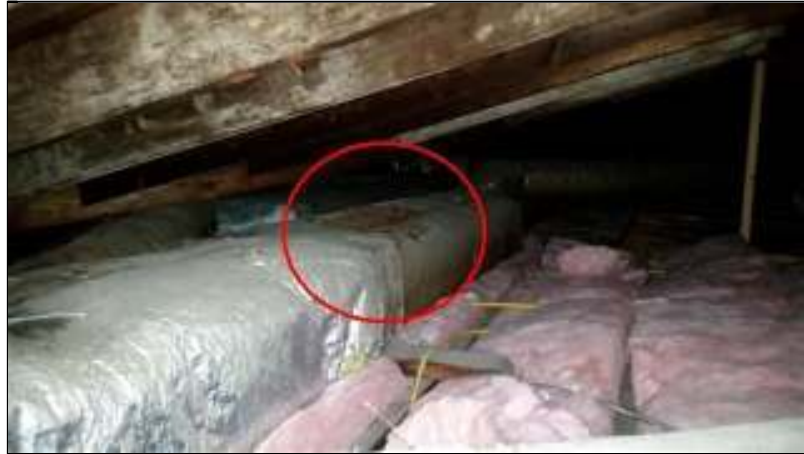
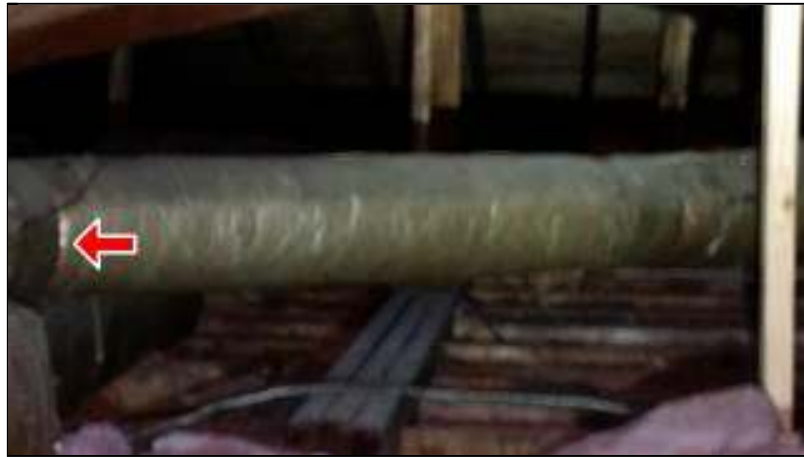
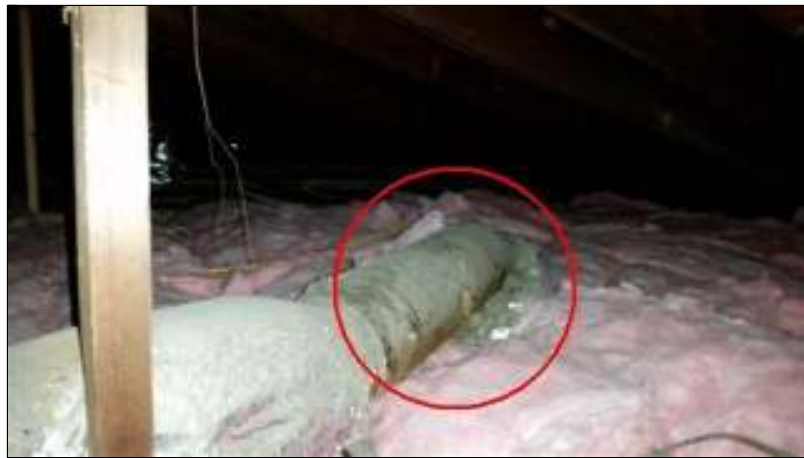
4.1 Item 3(Picture)

(2) The supply ducts are old and damaged in the attic. Energy loss is occurring. I recommend further inspection by a licensed HVAC contractor before the close of the inspection period.

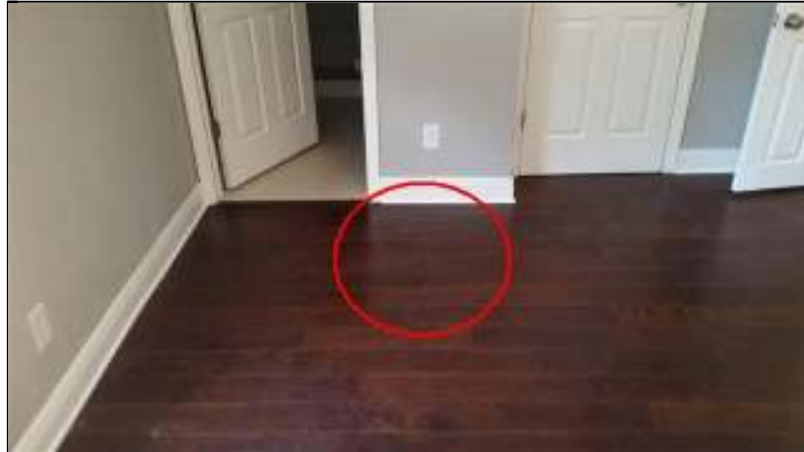
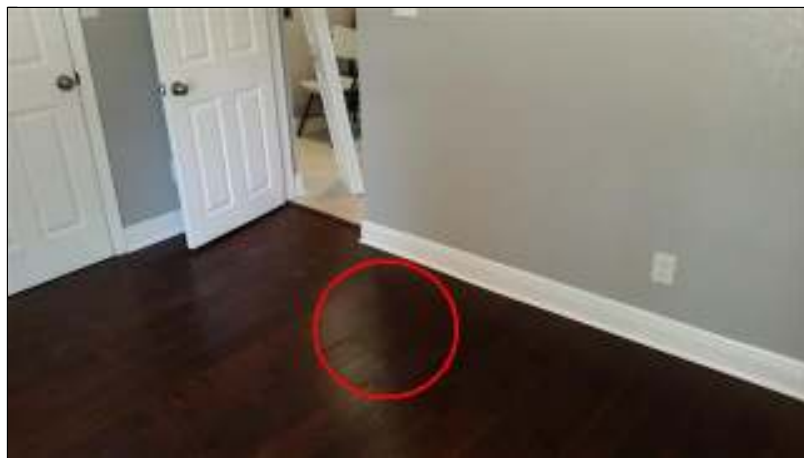
7.2 Item 1(Picture)

There are soft areas in the master bedroom floor that you may wish to have evaluated by a flooring contractor.

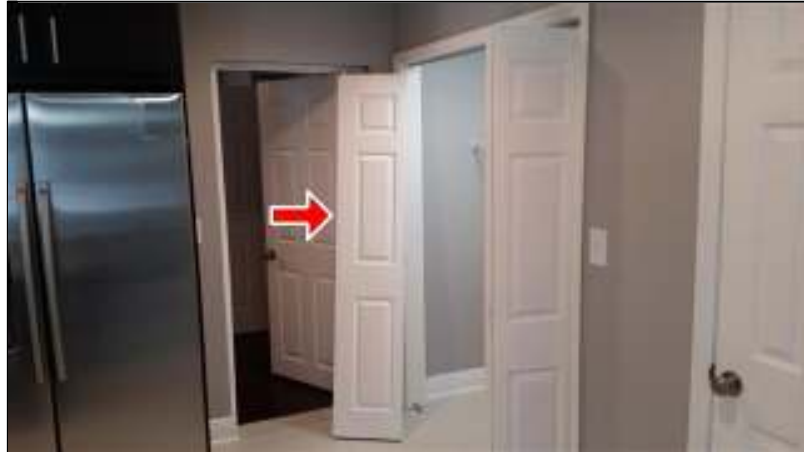
7.5 Item 2(Picture)

(2) The closet door is defective at the kitchen hall. A repair or replacement is needed.

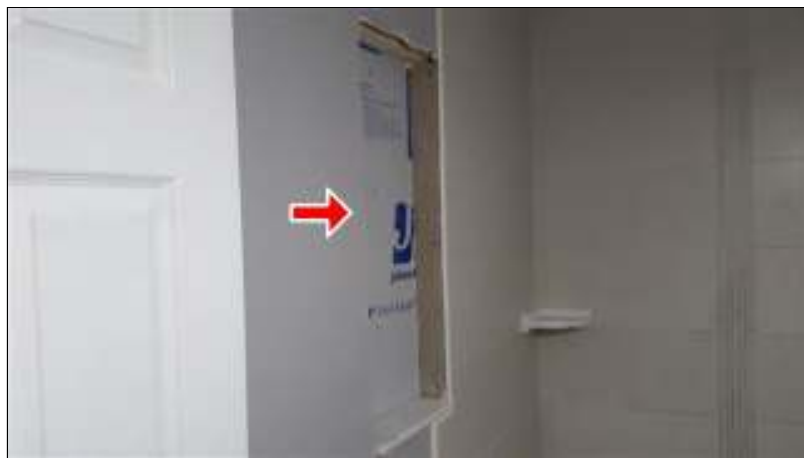
7.6 Item 1(Picture)

There is a missing window that requires replacement. I recommend an evaluation by a licensed window professional. The defect is located in the master bath.

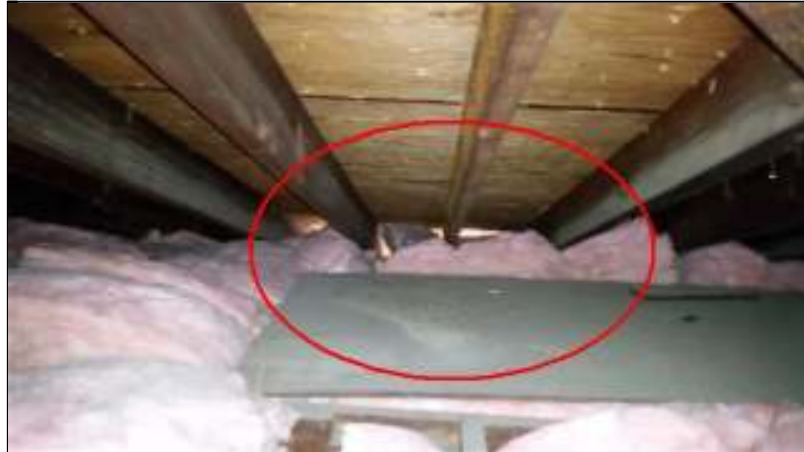
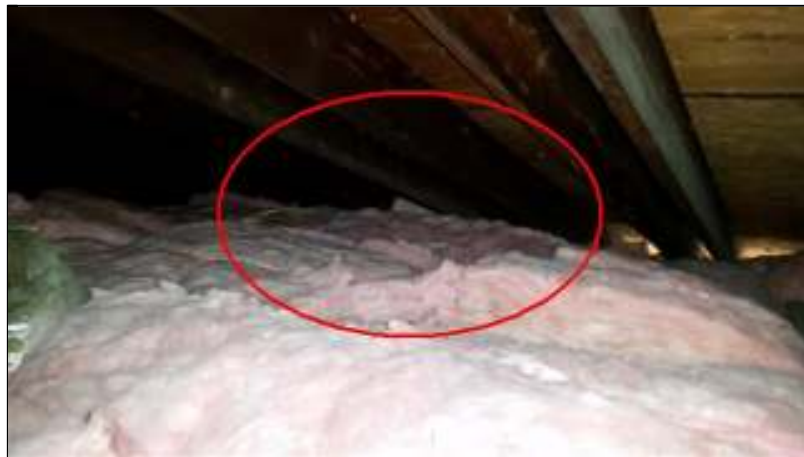
8.1 Item 1(Picture)

Insulation is blocking soffit vents in the garage and structure attic space. Blocked soffit vents decrease ventilation and increase attic temperature. This defect can lead to higher interior temperature and higher cooling costs. I recommend an evaluation by a professional.

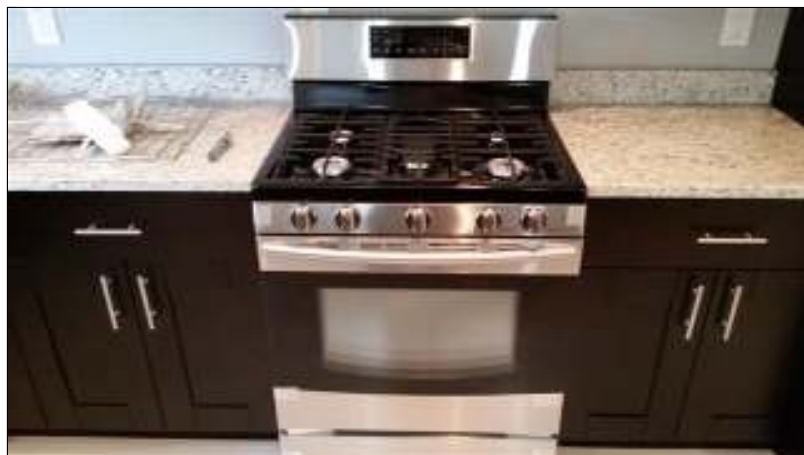
9.1 Item 1(Picture)

Gas range not attached to gas system but has an electric plug. I recommend an evaluation by a licensed appliance professional.

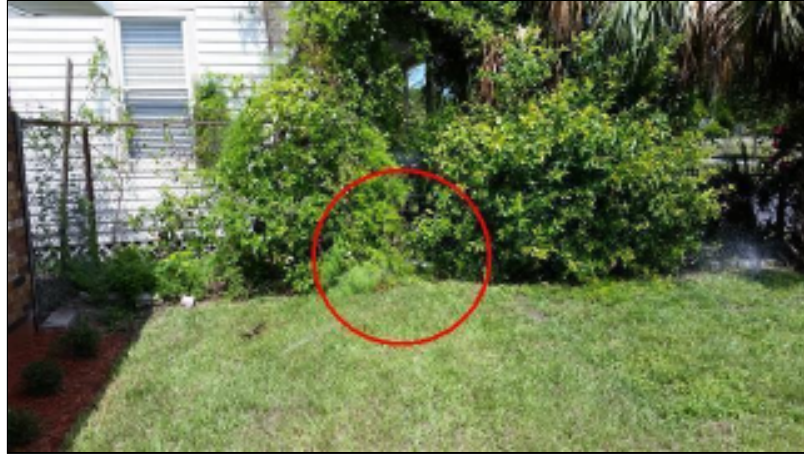
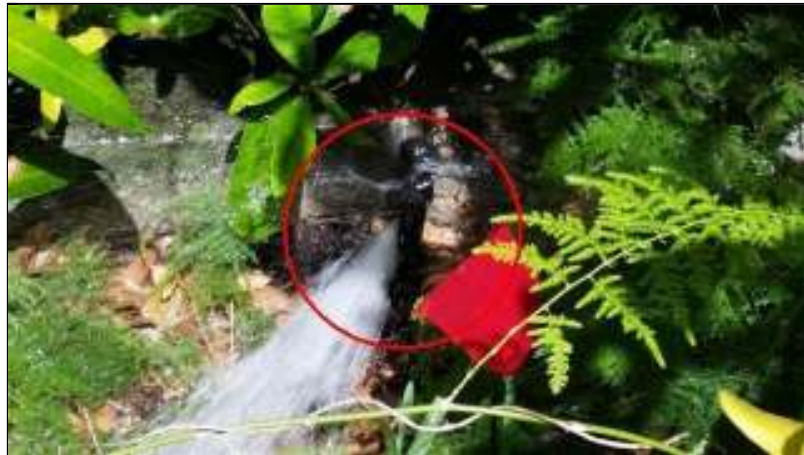
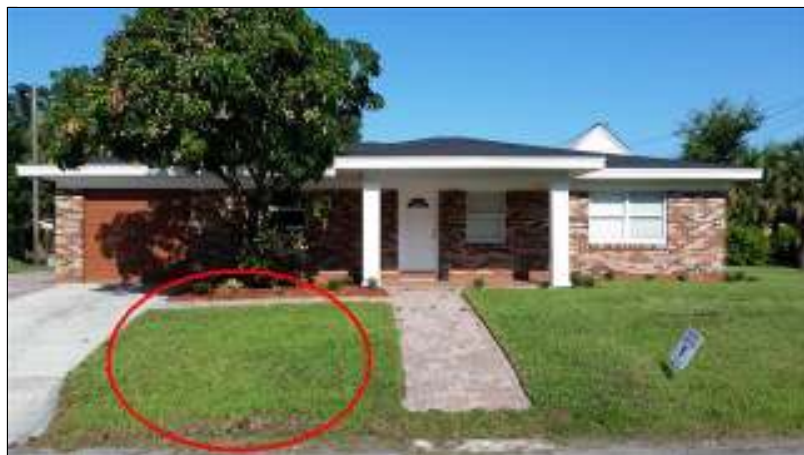
11.1 Item 2(Picture)

There are defective heads at the Arch St side of the structure and lack of heads at the Fremont Ave side. This defect can increase your water consumption and utility costs. I recommend evaluation by a licensed irrigation specialist.

11.1 Item 1(Picture) Arch St side of structure

11.1 Item 3(Picture) Fremont Ave side
